# Belgrade Spring Creek Synoptic Winter Sampling 2021

March 5th , 2025

#### Prepared by:

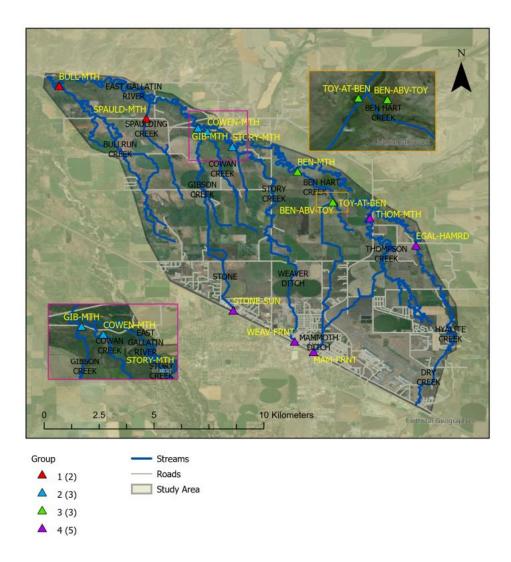
**Figure 1. Site Map.** Imagery from ESRI World Imagery; Streams from USGS National Hydrology Dataset; Roads from Montana Transportation Framework. Triangle colors indicate groups with numbers in the legend (the value in parentheses is the number of sites that team was initially assigned).

A synoptic water sampling event was conducted on December 17<sup>th</sup>, 2021 covering 10 sites on seven spring creeks and the East Gallatin River. Three additional ditch sites along the southern edge of the study area near I-90 were also observed to verify that these sites were dry and no surface water flow was entering the study area. Four teams of two individuals conducted the sampling and the sites monitored by each team are depicted in Figure 2. The only deviation from this map was that Team 2 (Sigler and Conti) made the observations of no-flow conditions at the three ditch sites (STONE-SUN, WEAV-FRNT, MAM-FRNT).

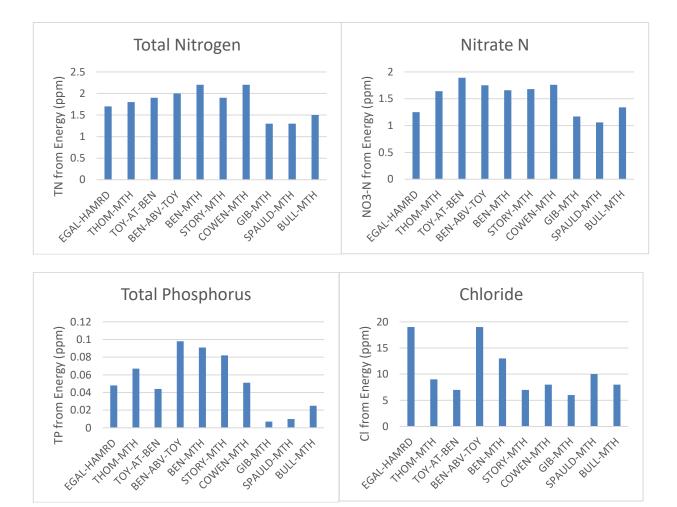
Figure 2. Nutrient and chloride concentrations from samples collected on December 17<sup>th</sup> 2021.

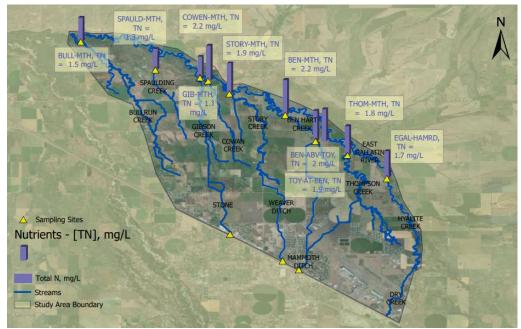
Figure 3. Map of total nitrogen concentrations. Imagery from ESRI World Imagery; Streams from USGS National Hydrology Dataset; Roads from Montana Transportation Framework; water quality data from this project.

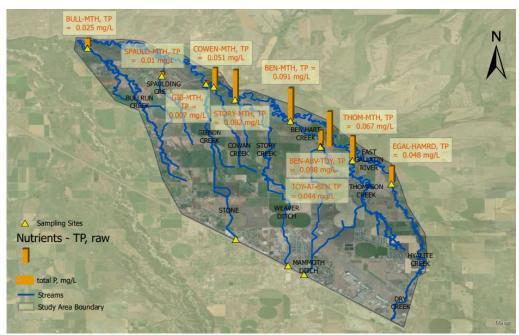
Figure 4. Map of total phosphorus concentrations. Imagery from ESRI World Imagery; Streams from USGS National Hydrology Dataset; Roads from Montana Transportation Framework; water quality data from this project.

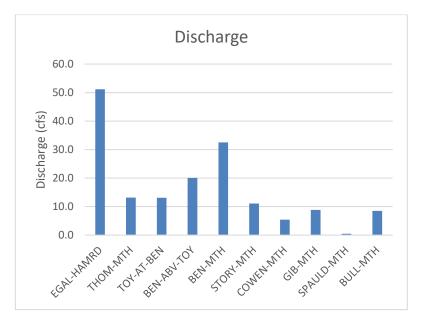
Figure 5. Discharge measured at the 10 sample sites on December 17<sup>th</sup> 2021.

Flow was measured at each site using the cross-section and velocity method, field parameters were measured with multi-parameter meters, and samples were collected for analysis at Energy Laboratories in Billings and at the Environmental Analytical Lab on the MSU Campus.

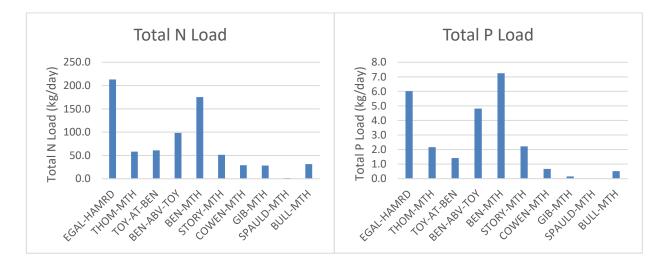
Figure 6. Total nitrogen and total phosphorus loads at the 10 sample sites on December 17<sup>th</sup> 2021.

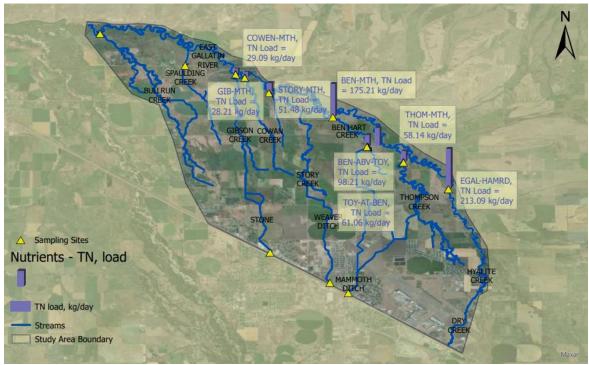
Figure 7. Map of total nitrogen loads. Imagery from ESRI World Imagery; Streams from USGS National Hydrology Dataset; Roads from Montana Transportation Framework; water quality data from this project.

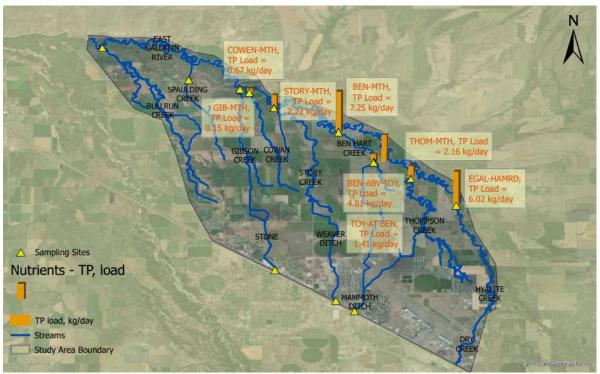
Figure 8. Map of total phosphorus loads. Imagery from ESRI World Imagery; Streams from USGS National Hydrology Dataset; Roads from Montana Transportation Framework; water quality data from this project.

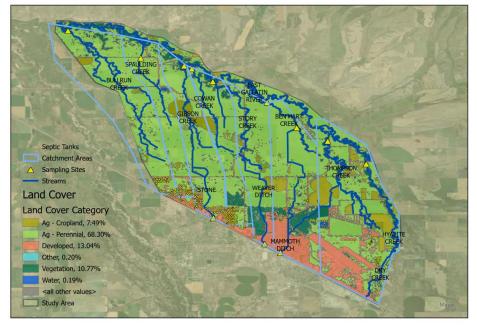
#### **Belgrade Nutrients Project - Land Cover and Septic Systems**

Figure 9. Land use in proximity to spring creeks. Land area near streams is delineated by the blue lines, which are labeled "catchment areas" on the map, but the true catchment areas extend far to the south outside the study area and are not well known. These straight lines around streams were drawn to facilitate a very course level assessment of the land use in proximity to each stream and are not intended to represent the true catchment areas for the groundwater entering the streams.

Table 2. Land use for areas proximate to streams, labeled as "catchment areas" in Figure 9.

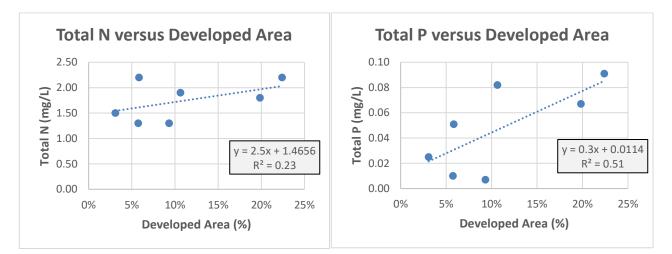
Figure 10. Regression between nutrient concentration at the mouth of each spring creek and the percent of area proximate to the stream (Figure 9 and Table 2) that is categorized as developed land use.

Table 3. Relationship between nutrient concentration and land use in proximity to spring creeks in Table2. A positive slope indicates an increase nutrient concentration for an increase in percent land use in<br/>proximity to the stream. The R<sup>2</sup> value indicates how strong the correlation is between nutrient<br/>concentration and land use.

Total Nit	rogen	Total Phosphorus		
Land Use	Slope	R <sup>2</sup>	Slope	R <sup>2</sup>	
Developed Area	+	0.23	+	0.51	
Cropland agriculture	+	0.02	+	0.10	
Perennial vegetation agriculture	-	0.38	-	0.61

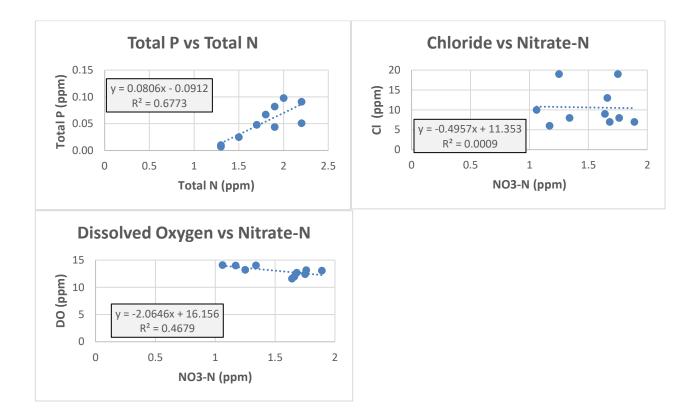
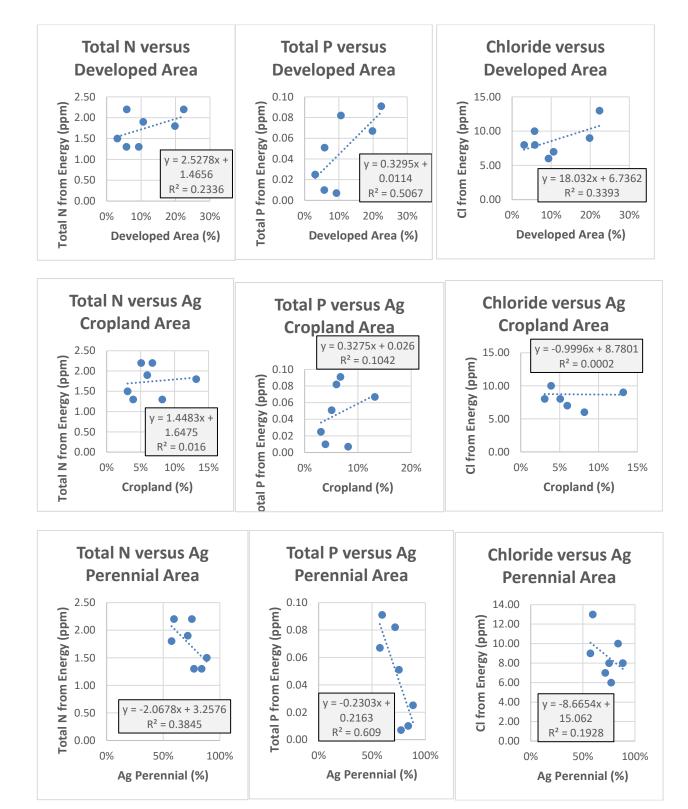
#### **APPENDIX 1. RELATIONSHIPS BETWEEN WATER QUALITY PARAMETERS**

The concentrations of total phosphorus and total nitrogen are correlated across sample sites.

Chloride and nitrate concentrations do not show a relationship. Chloride is commonly evaluated as a possible indicator that nitrate may be derived from wastewater disposal, but this approach assumes high levels of chloride in wastewater and does not account for nitrate losses in transport due to denitrification.

A negative correlation observed between dissolved oxygen and nitrate concentration raises questions about higher denitrification potential in streams with higher nitrate concentrations.
