RIPARIAN AREA MANAGEMENT

Proper Functioning Condition Assessment for Lotic Areas

Technical Reference 1737-15
Second Edition
2015

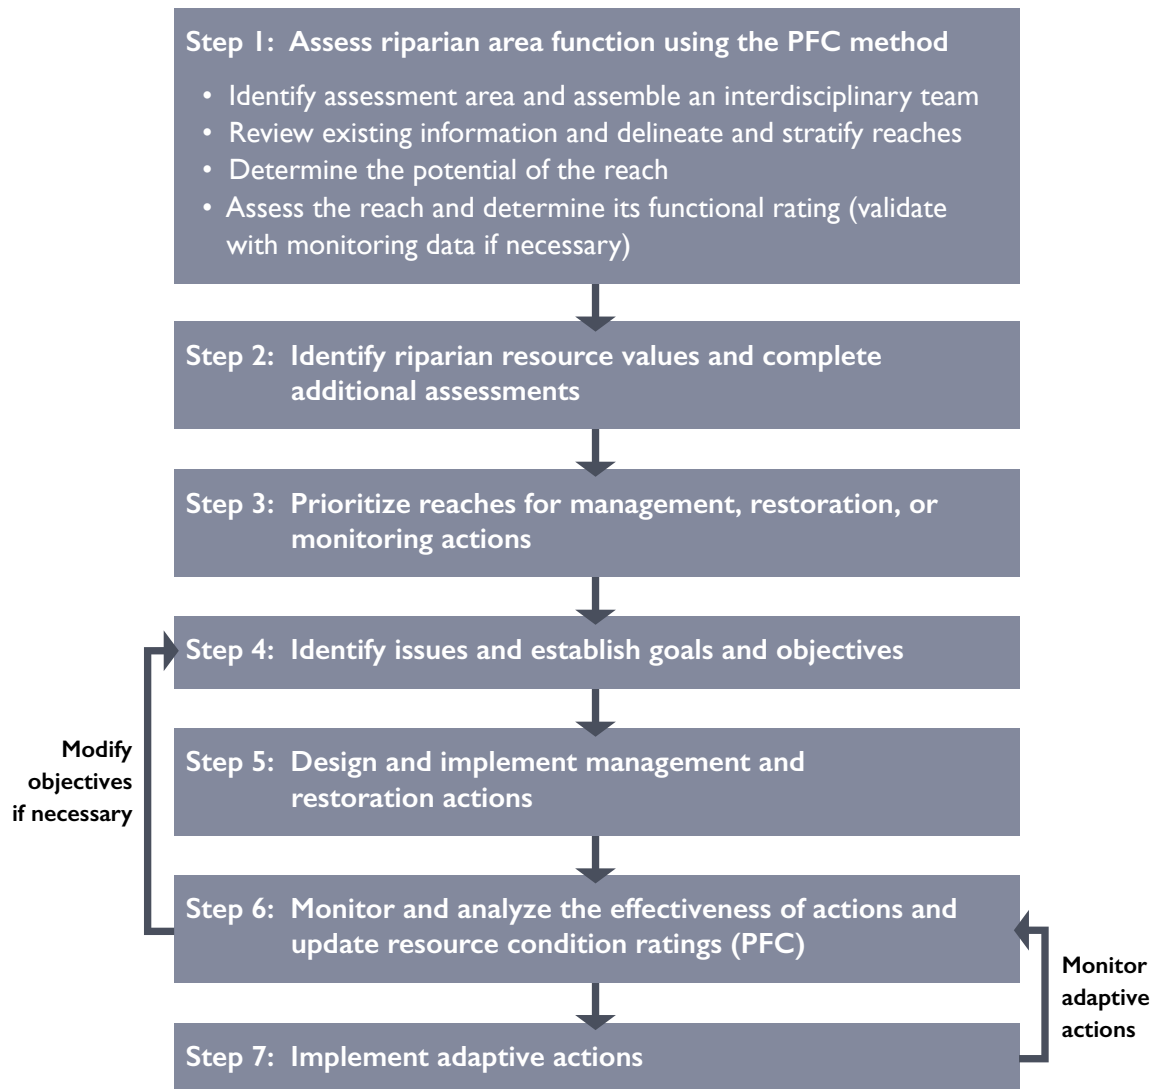
Figure 2. Recommended steps for managing riparian areas using an integrated process. After effectiveness monitoring has been done (step 6), initial objectives are validated and modified if necessary. After implementing adaptive actions, step 6 is repeated to monitor the effectiveness of those actions.

A PFC assessment can be incorporated into an integrated riparian management process through a logical sequence of actions (figure 2).

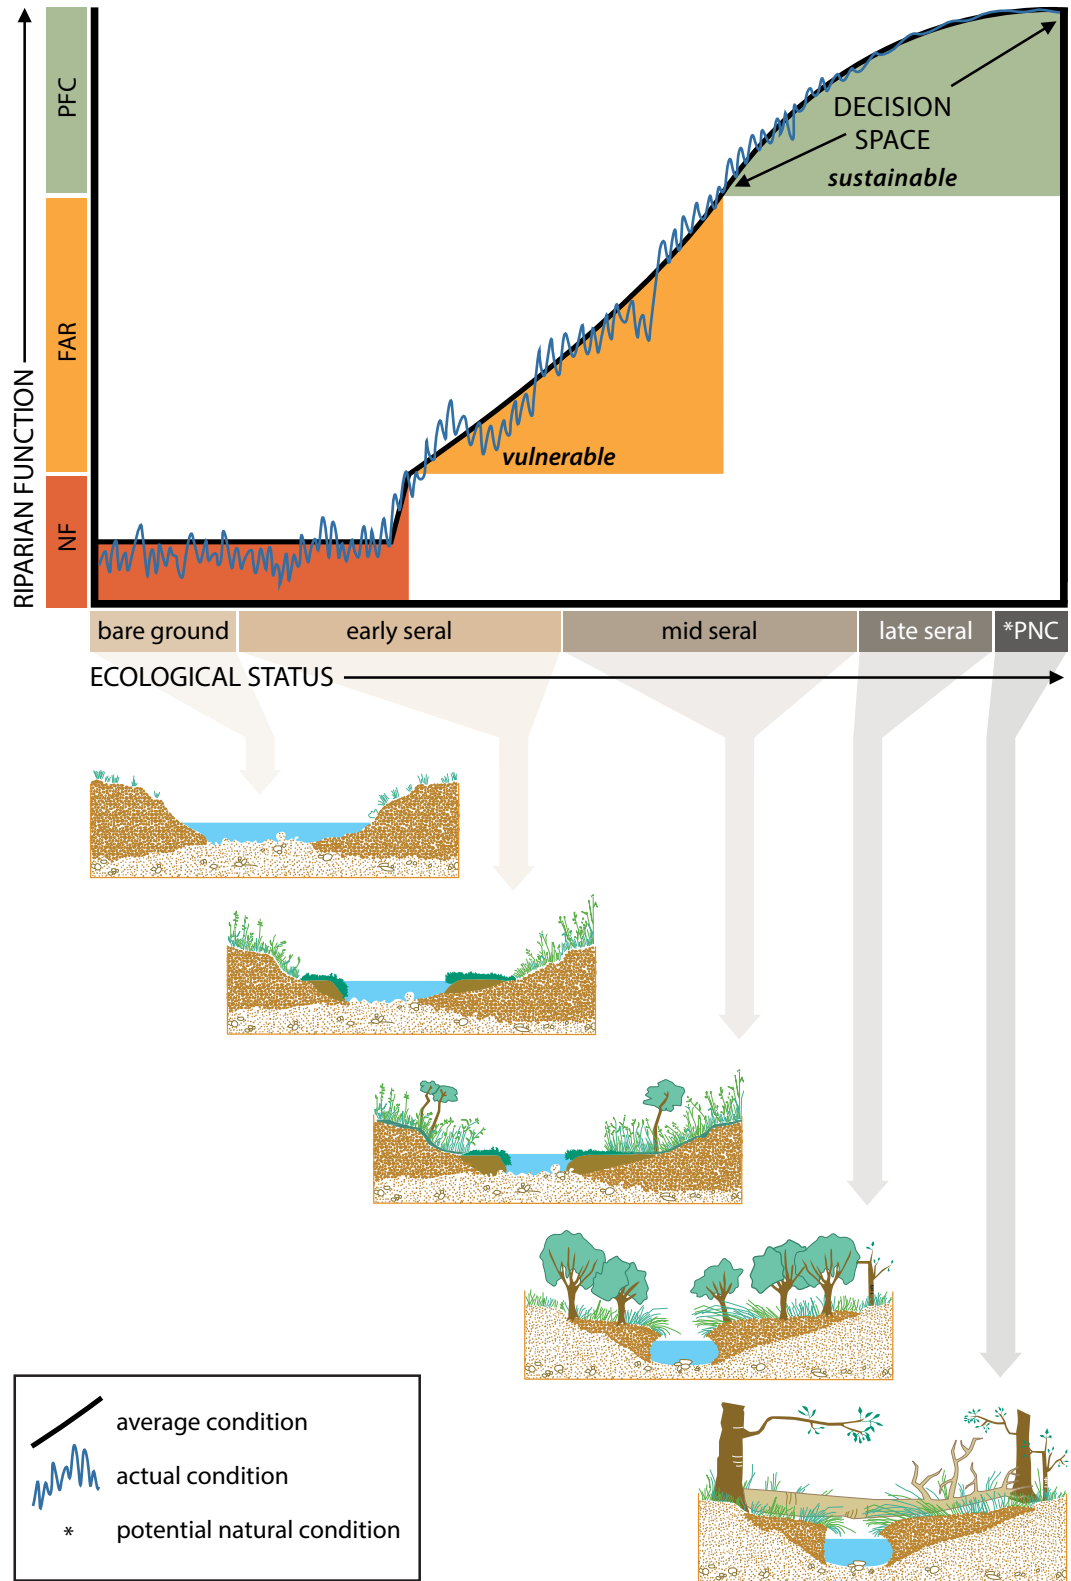
Figure 38. An example of succession as it relates to riparian recovery and physical function. Streams rated functional-at risk are vulnerable to impairment from moderate- to high-flow events. Streams in PFC are better able to withstand impairment from these events and thereby can sustainably produce certain values. Not all streams will follow this successional progression.

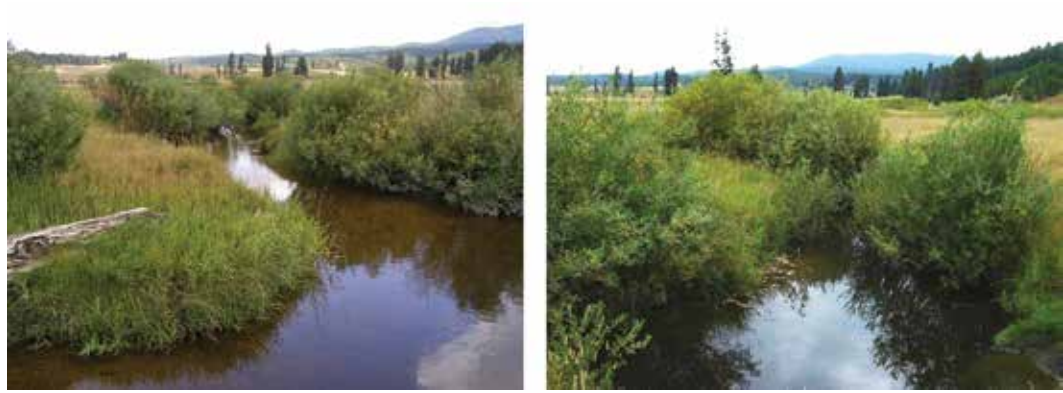
Reach 1: Proper functioning condition

Rating and Key Factors: Reach 1 is rated as PFC because all assessment items were answered “yes” and the reach has adequate vegetation to dissipate energy and meet the comprehensive definition of PFC. Not only is this reach in PFC, it is very near potential. This reach has clearly recovered from the past channel incision as willows and other riparian stabilizers have become reestablished and the channel has narrowed. The channel has adequate floodplain connectivity, the channel shape is appropriate for the landscape setting, and multiple species and age classes of vigorous riparian stabilizers are present. Although there is some streambank instability present on some outside meander bends in the form of slump blocks, it is limited in extent. It is not uncommon for streams to exhibit some streambank instability at PFC or even at potential.
